## DURING CONSTRUCTION ANNUAL REPORT YEAR 1

# DURHAM-YORK ENERGY CENTRE - SURFACE WATER MONITORING PROGRAM

**Report Number: 12-1151-0155 (5000)**

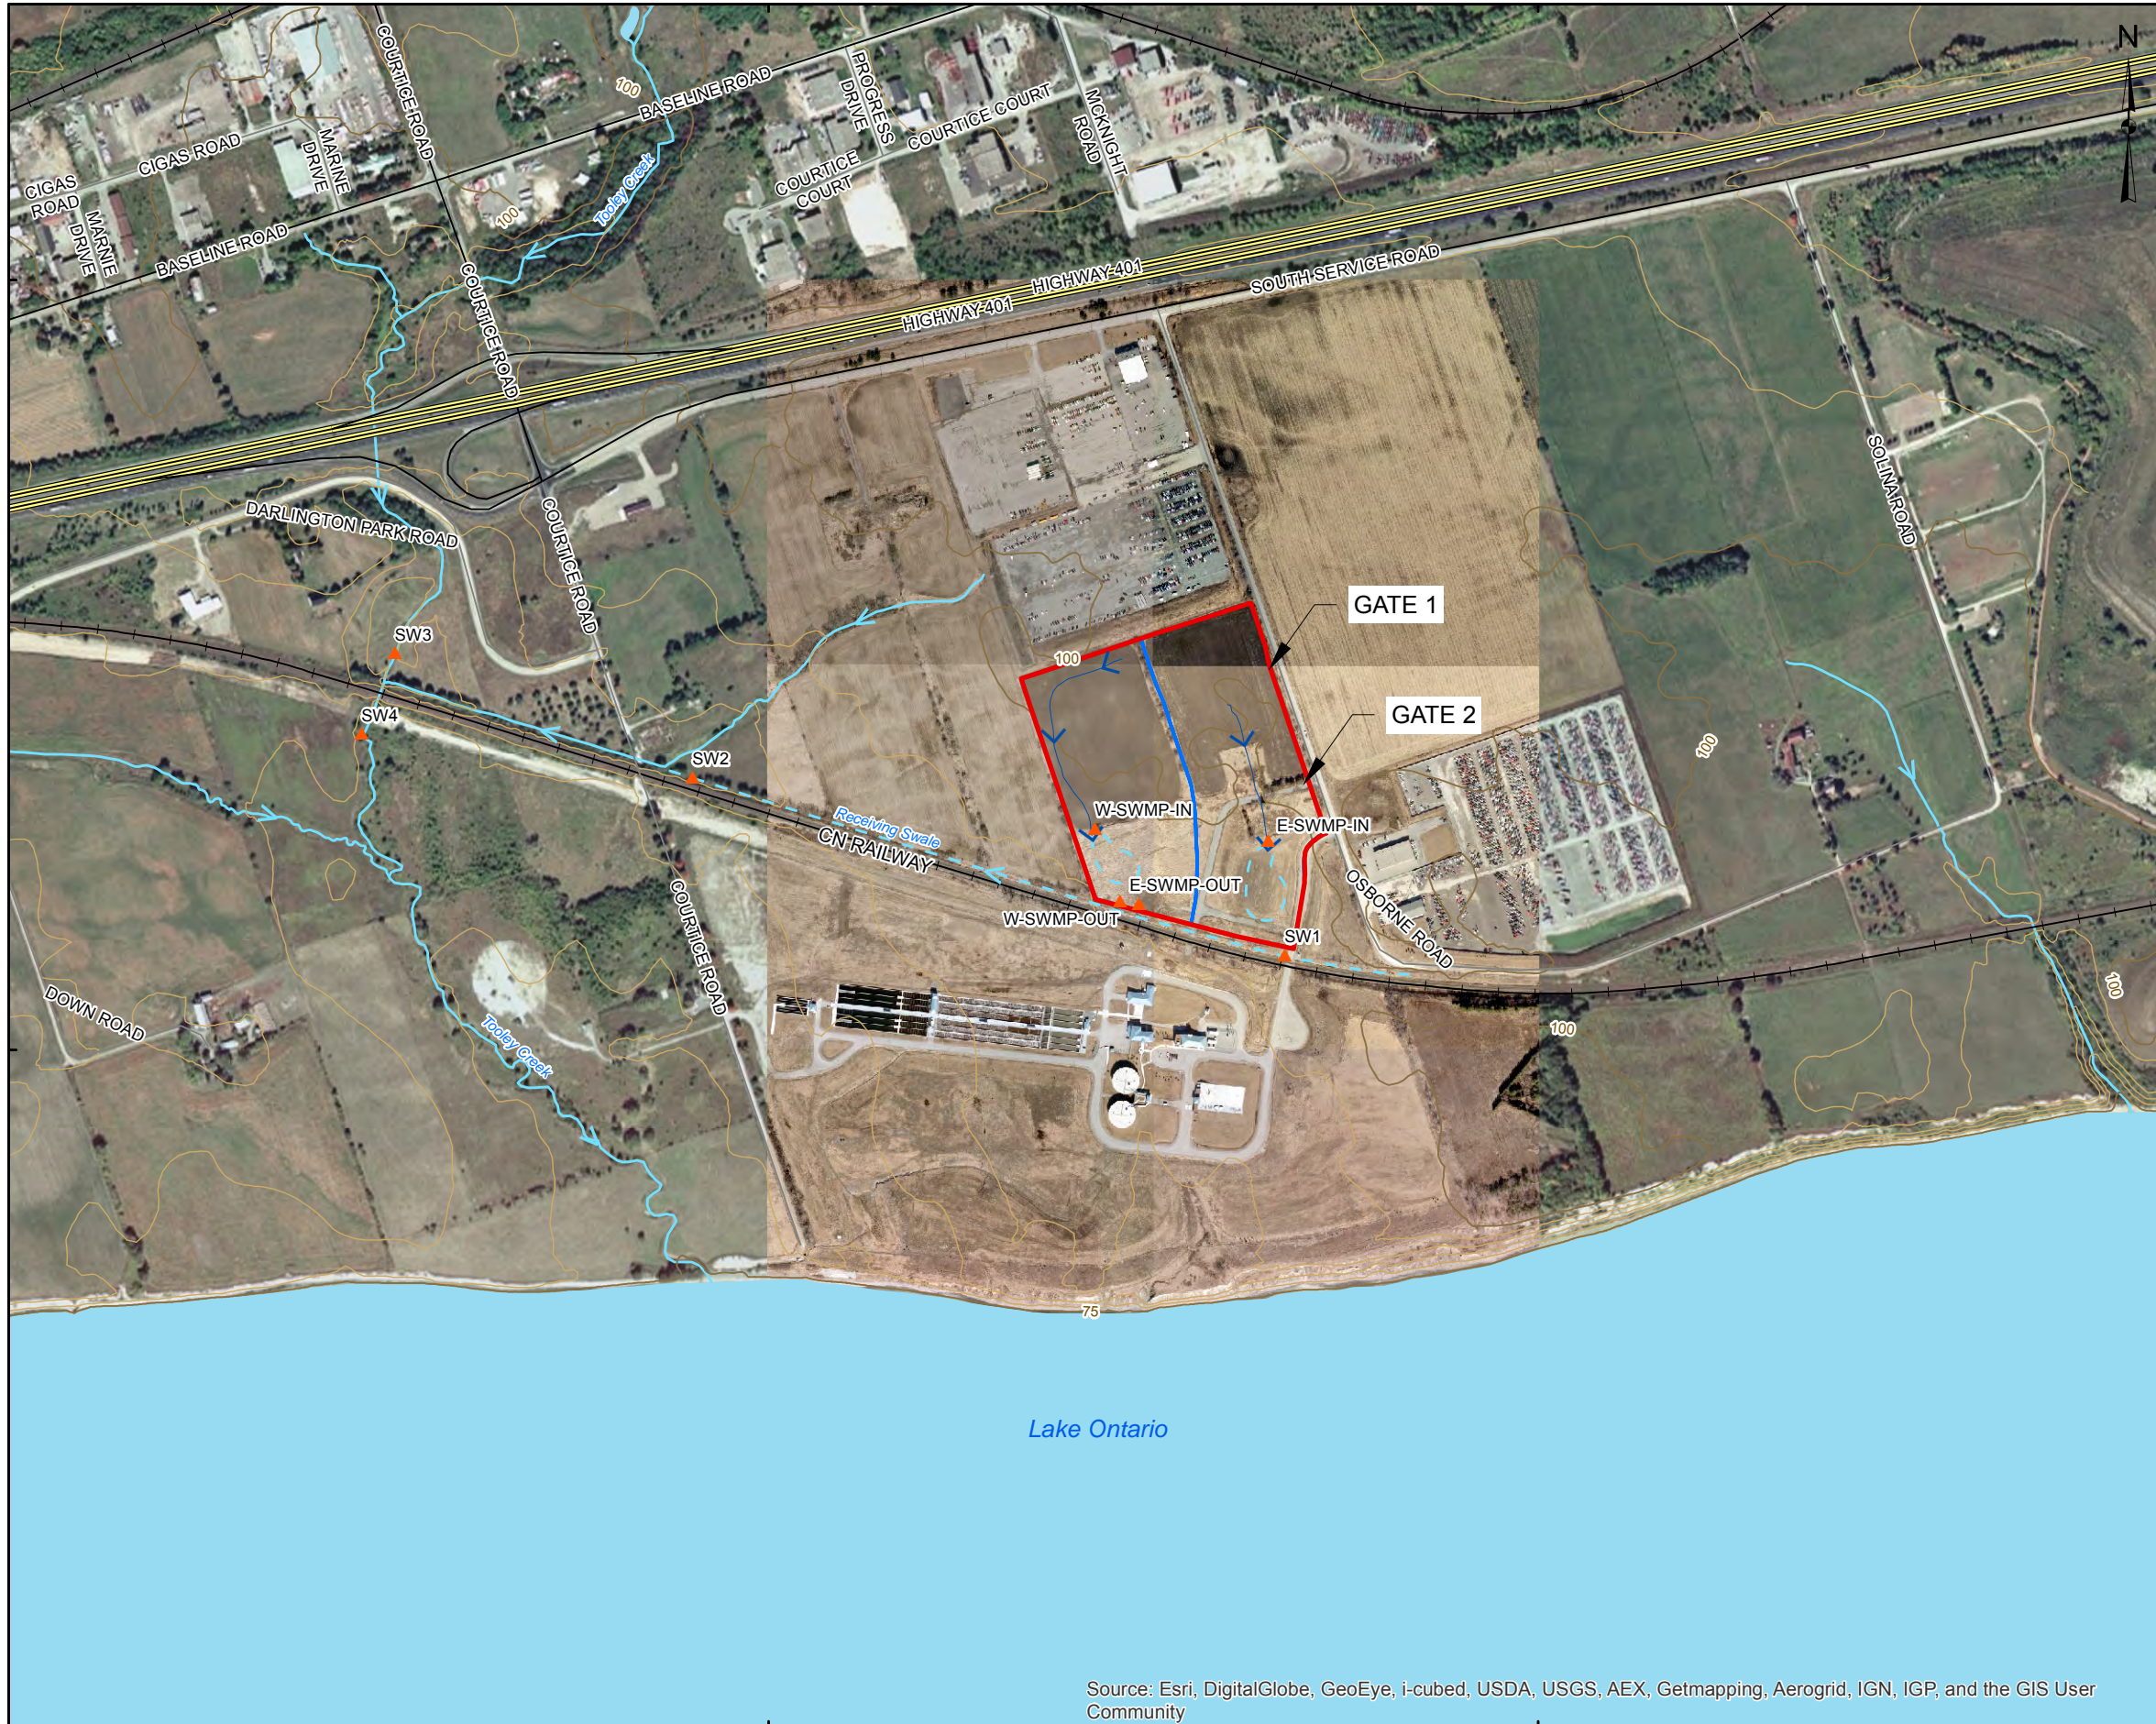
The on and off-Site surface water sampling stations (SW1 to SW4, E-SWMP-IN, E-SWMP-OUT, W-SWMP-IN, and W-SWMP-OUT) are shown on Figure 1. Each station is described in more detail below, will conditions during sampling events shown in Appendix C.
