DURING CONSTRUCTION ANNUAL REPORT YEAR 2

DURHAM YORK ENERGY CENTRE - SURFACE WATER MONITORING PROGRAM

Report Number: 12-1151-0155_5000

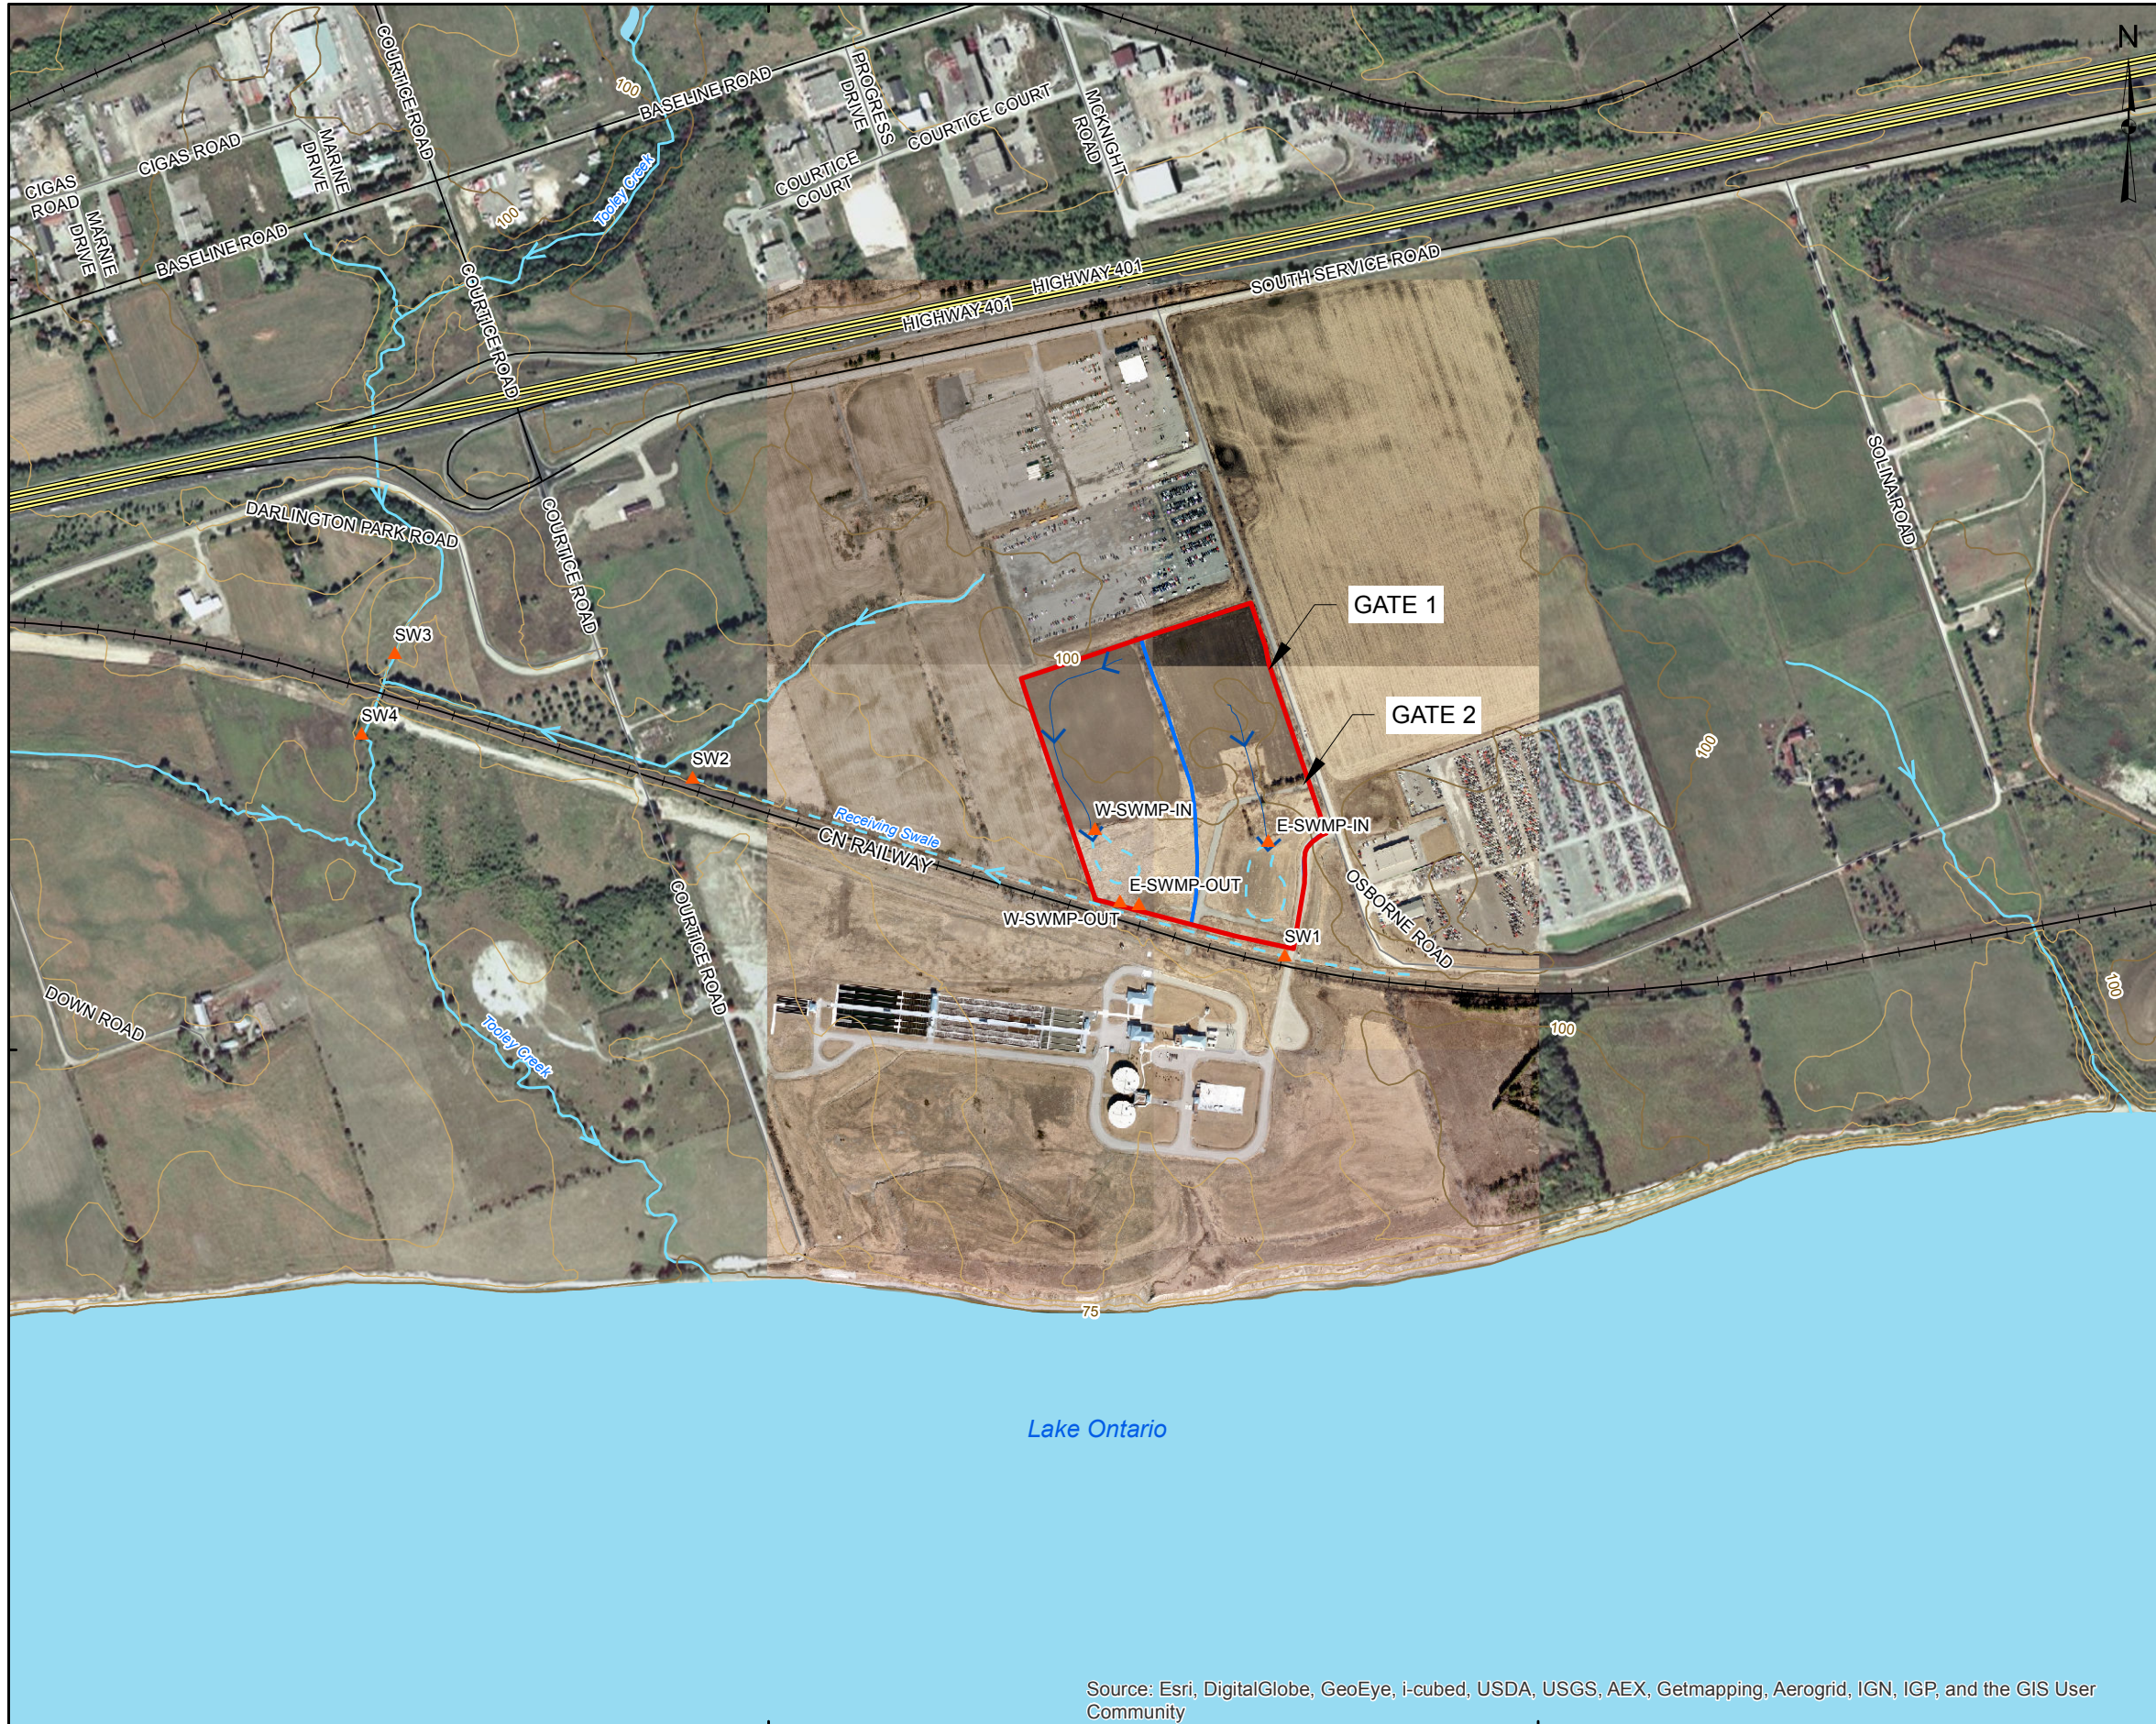
The on and off-Site surface water sampling stations (SW1 to SW4, E-SWMP-IN, E-SWMP-OUT, W-SWMP-IN, and W-SWMP-OUT) are shown on Figure 1. Changes to locations SW1 and SW2 on/after September 30, 2013, due to construction are shown on Figure 2. Each station is described in more detail below, with conditions during sampling events shown in Appendix C.
